Manhole Inspection Summary

Manhole # S33A__009MH

Location Address: **214 MONUMENT ST**

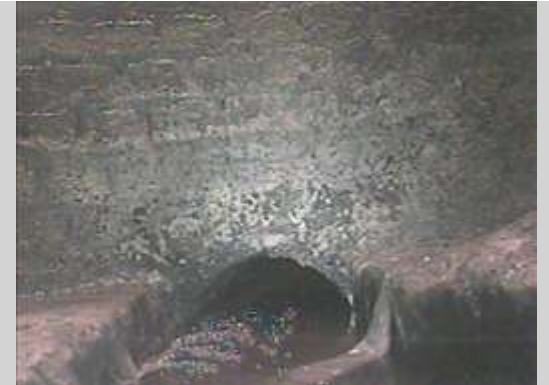
12 O'Clock Outflow

10 in. Circular Gravity Sewer
Pipe Out @ 12 O'Clock

Pipe Height: **6** (in.) Rod and Bar
Pipe Material: **Clay** ☐ Pipe Lined
Invert Depth: **12.13** (ft.) Flow Characteristics: **Slow**
Deposits: ☒ None ☐ Mud ☐ Sludge ☐ **Debris** ☐ Grease
Silt Depth: (in.) Deposits Extent:
Infiltration: **None** Pipe Seal Cond: **Sound**

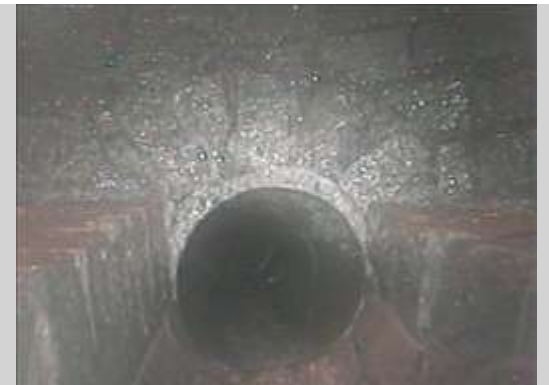
4 O'Clock Inflow

8 in. Circular Gravity Sewer
Pipe In @ 4 O'Clock

Pipe Height: **4.8** (in.) Rod and Bar
Pipe Material: **Clay** ☐ Pipe Lined
Invert Depth: **11.62** (ft.) Flow Characteristics: **Slow**
Deposits: ☒ None ☐ Mud ☐ Sludge ☐ **Debris** ☐ Grease
Silt Depth: (in.) Deposits Extent:
Infiltration: **None** Pipe Seal Cond: **Sound**

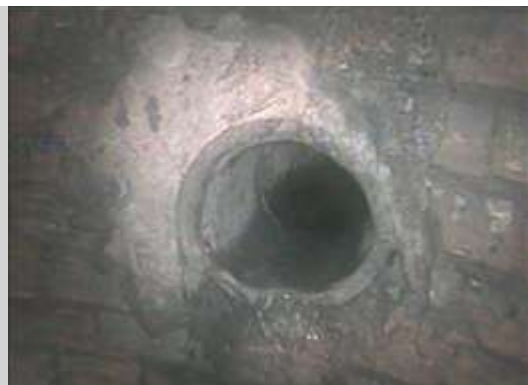
6 O'Clock Inflow

10 in. Circular Gravity Sewer
Pipe In @ 6 O'Clock

Deposits: ☐ None ☐ Mud ☐ Sludge ☒ **Debris** ☐ Grease

Silt Depth: **4** (in.) Deposits Extent: **Light**
